Technical Note N-855

MAINTENANCE PAINTING OF BUILDINGS--FIRST PROGRESS REPORT

8 November 1966

U. S. NAVAL CIVIL ENGINEERING LABORATORY
Port Hueneme, California 93041

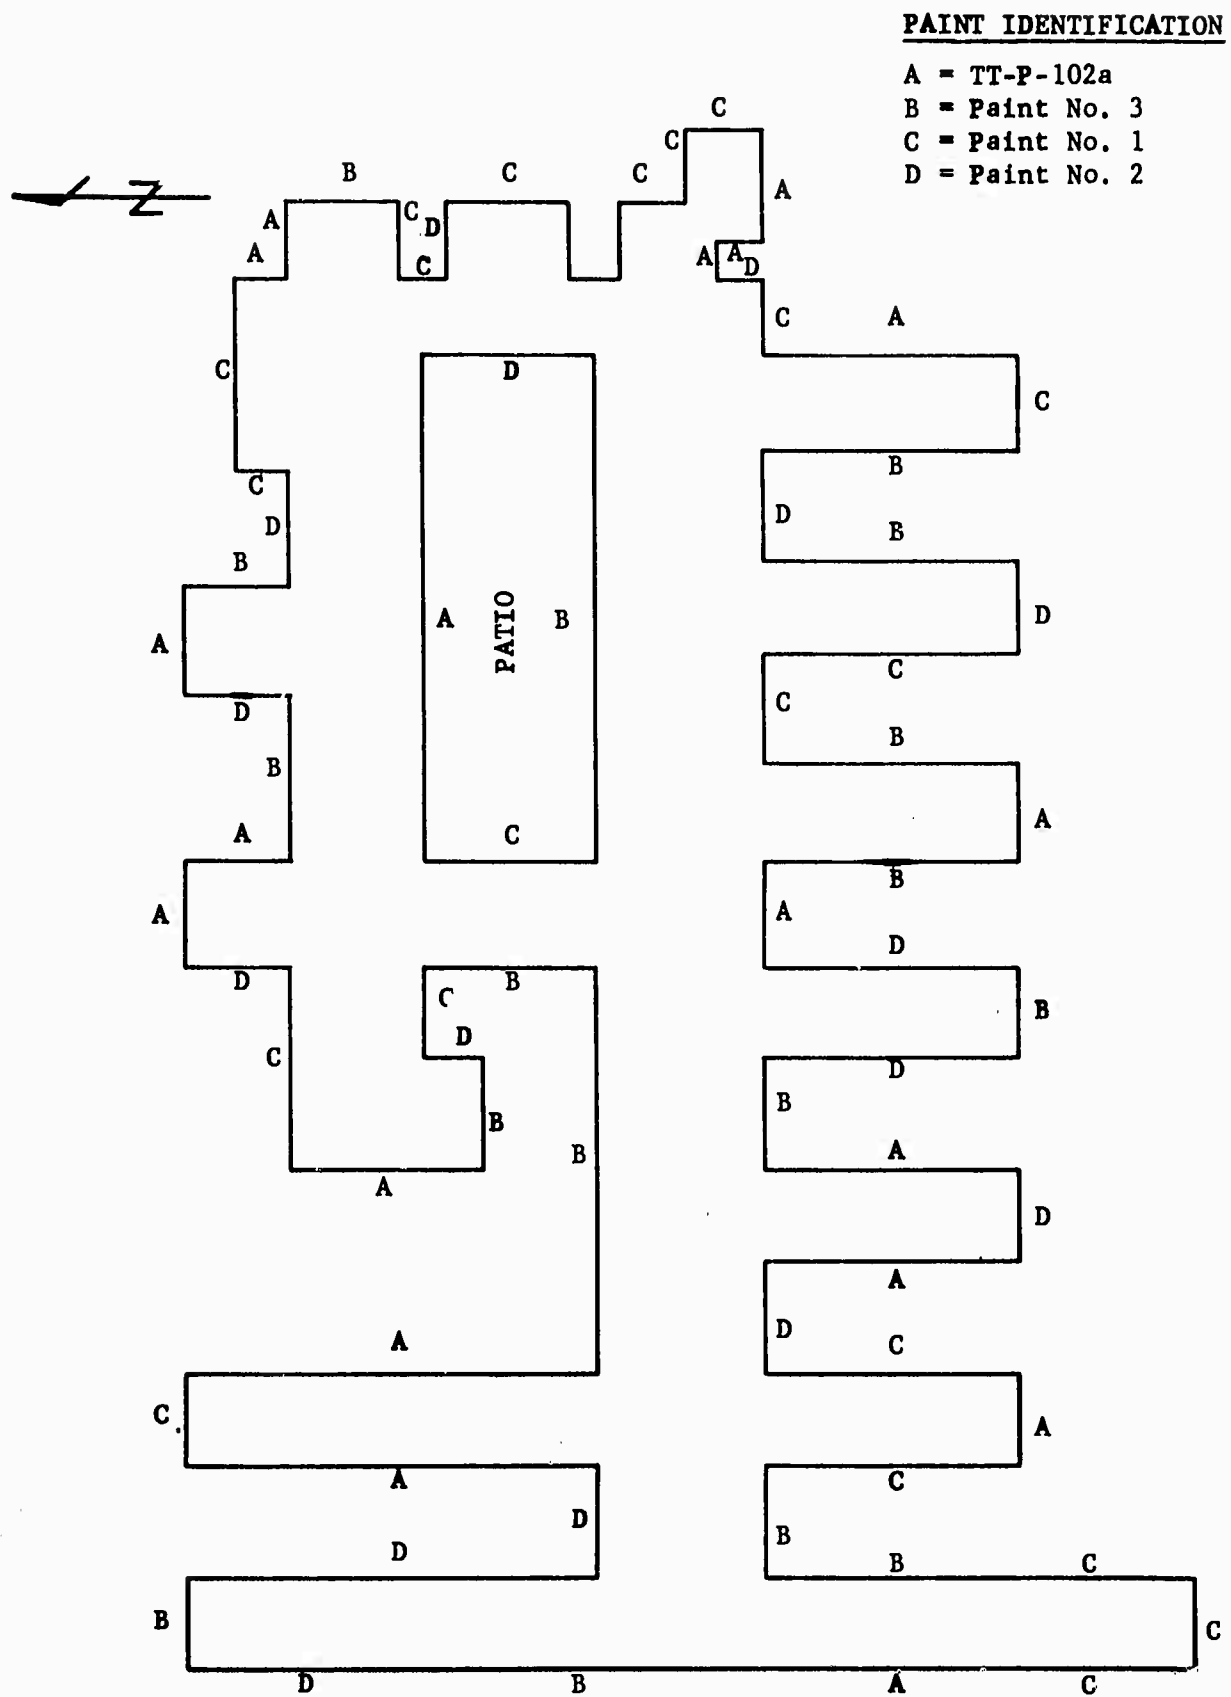
Figure 1. Drawing of CBC Base Hospital.

The CBCenter Hospital is well suited for a painting experiment because it has many different exposures. There are seven wings on the southern part of the building each of which have south, east and west exposures. The building surface was divided into seventy-six sections, based primarily on the irregular structural design of the building. One of four different paints, designated as A, B, C, or D, was randomly chosen to be applied to each section, as shown in Figure 1.
